SITE ANALYSIS

MABE

community — open space

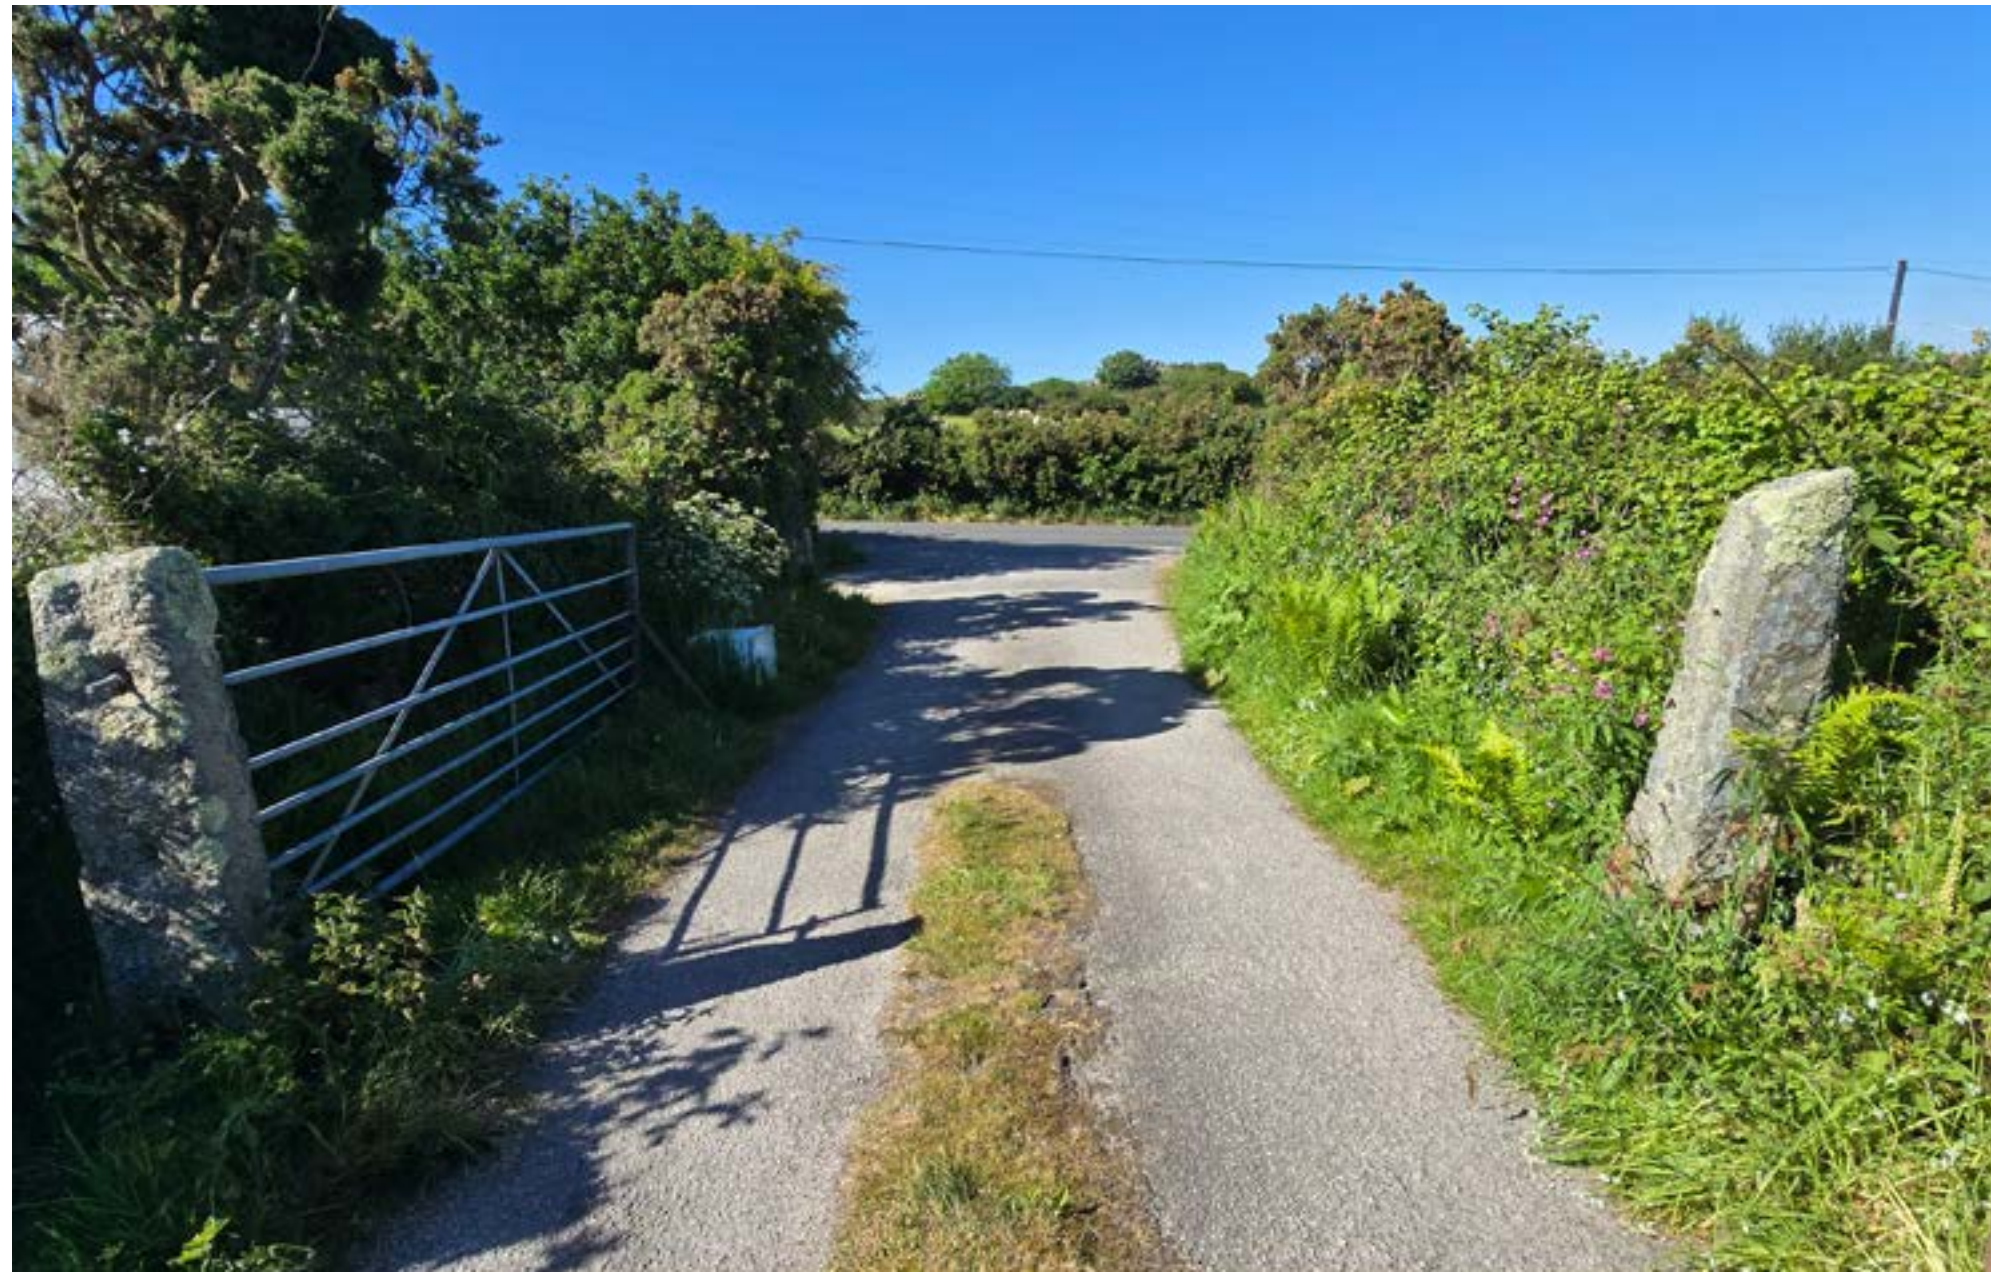
1) Quarry Lane looking North to Antron Hill;
 Poor visibility from the junction, with the lane also being used by quarry lorries.
 The lane is also a designated Public Right of Way, path 217/17/1.

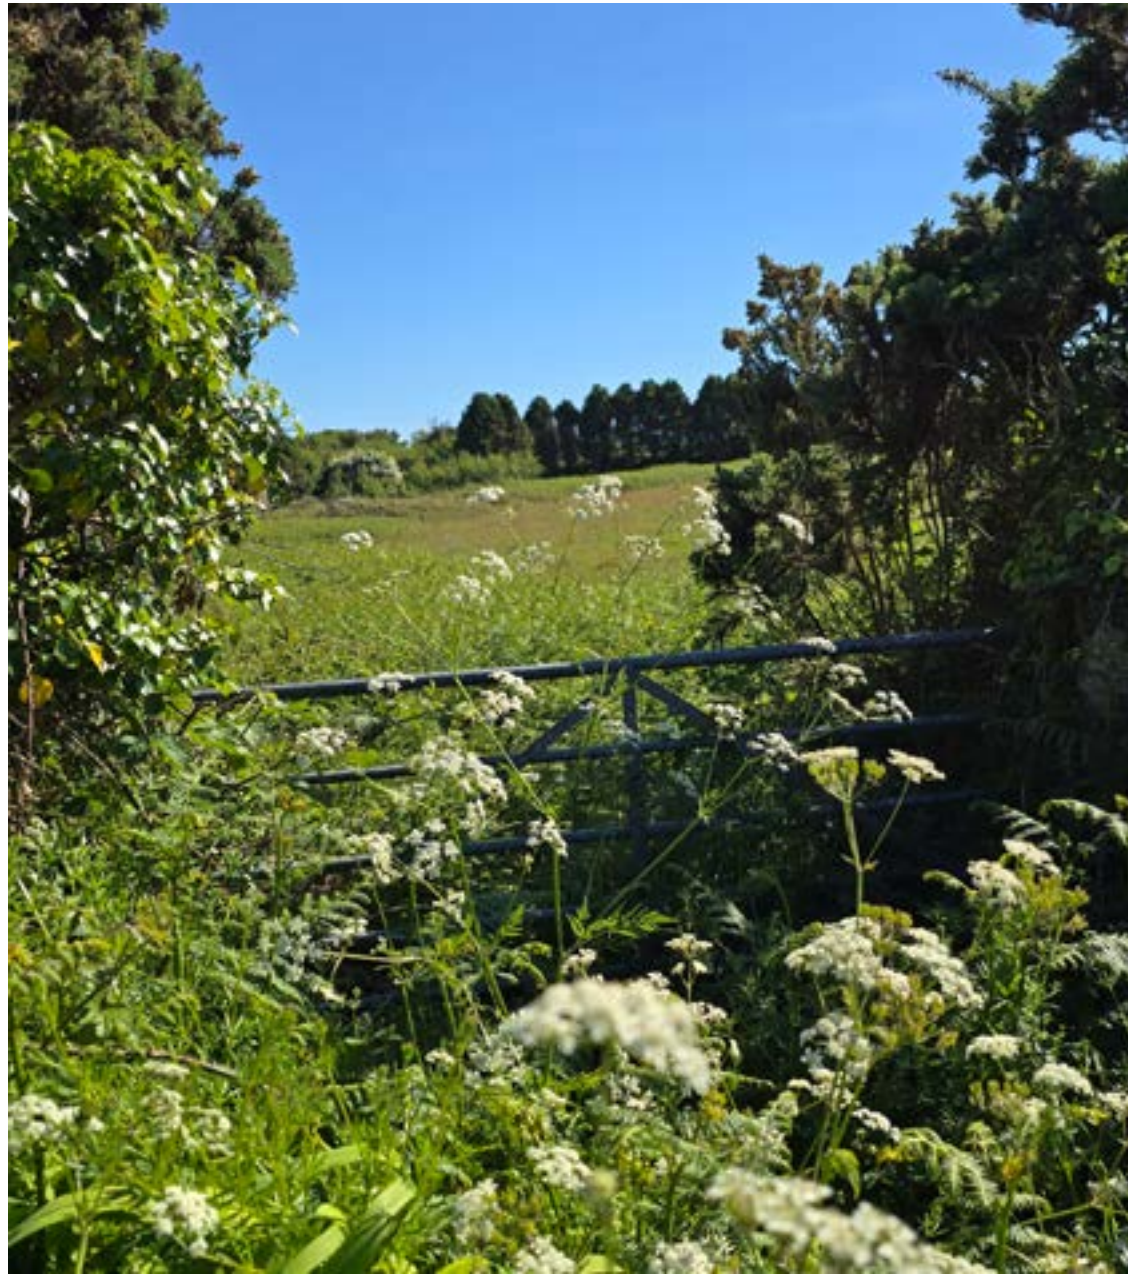
2) Existing entrance;
 Existing field gated entrance along Antron Hill,
 currently overgrown.

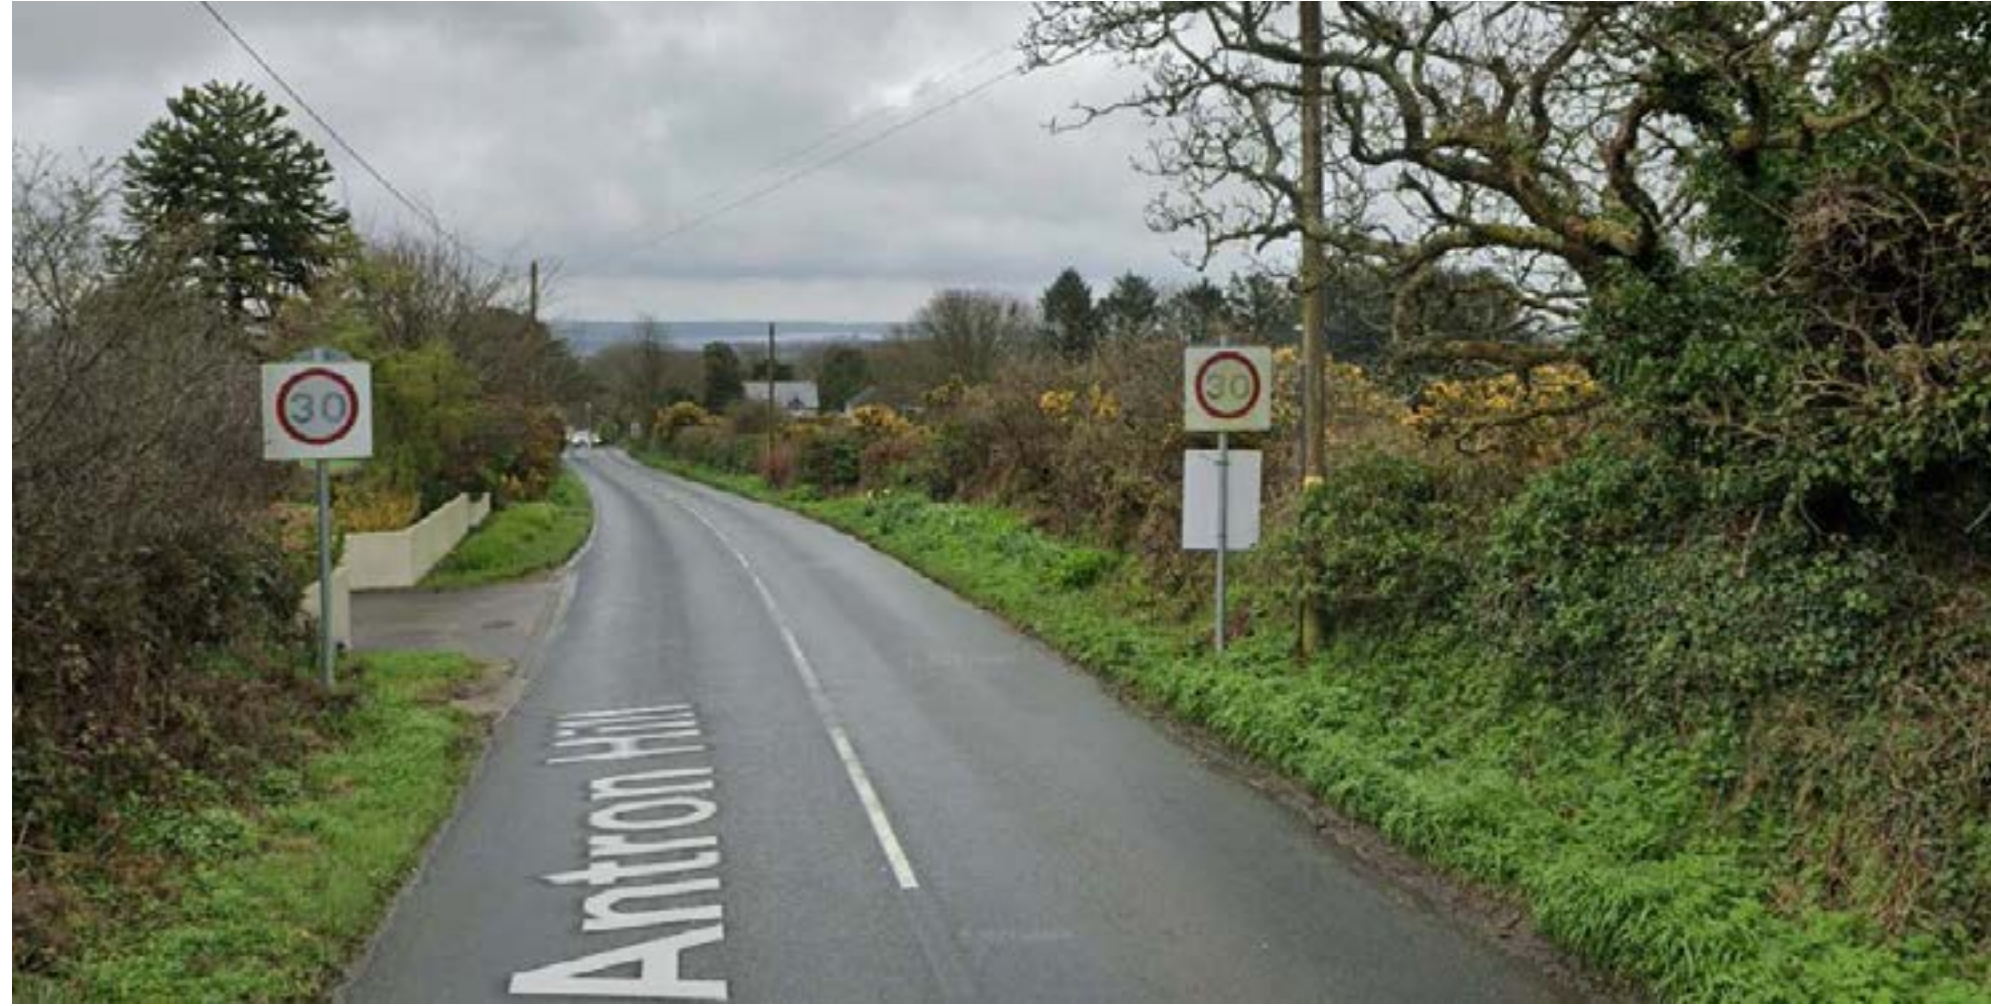
3) Antron Hill Looking East;
 High Cornish Hedgebanks and speed restrictions in place.

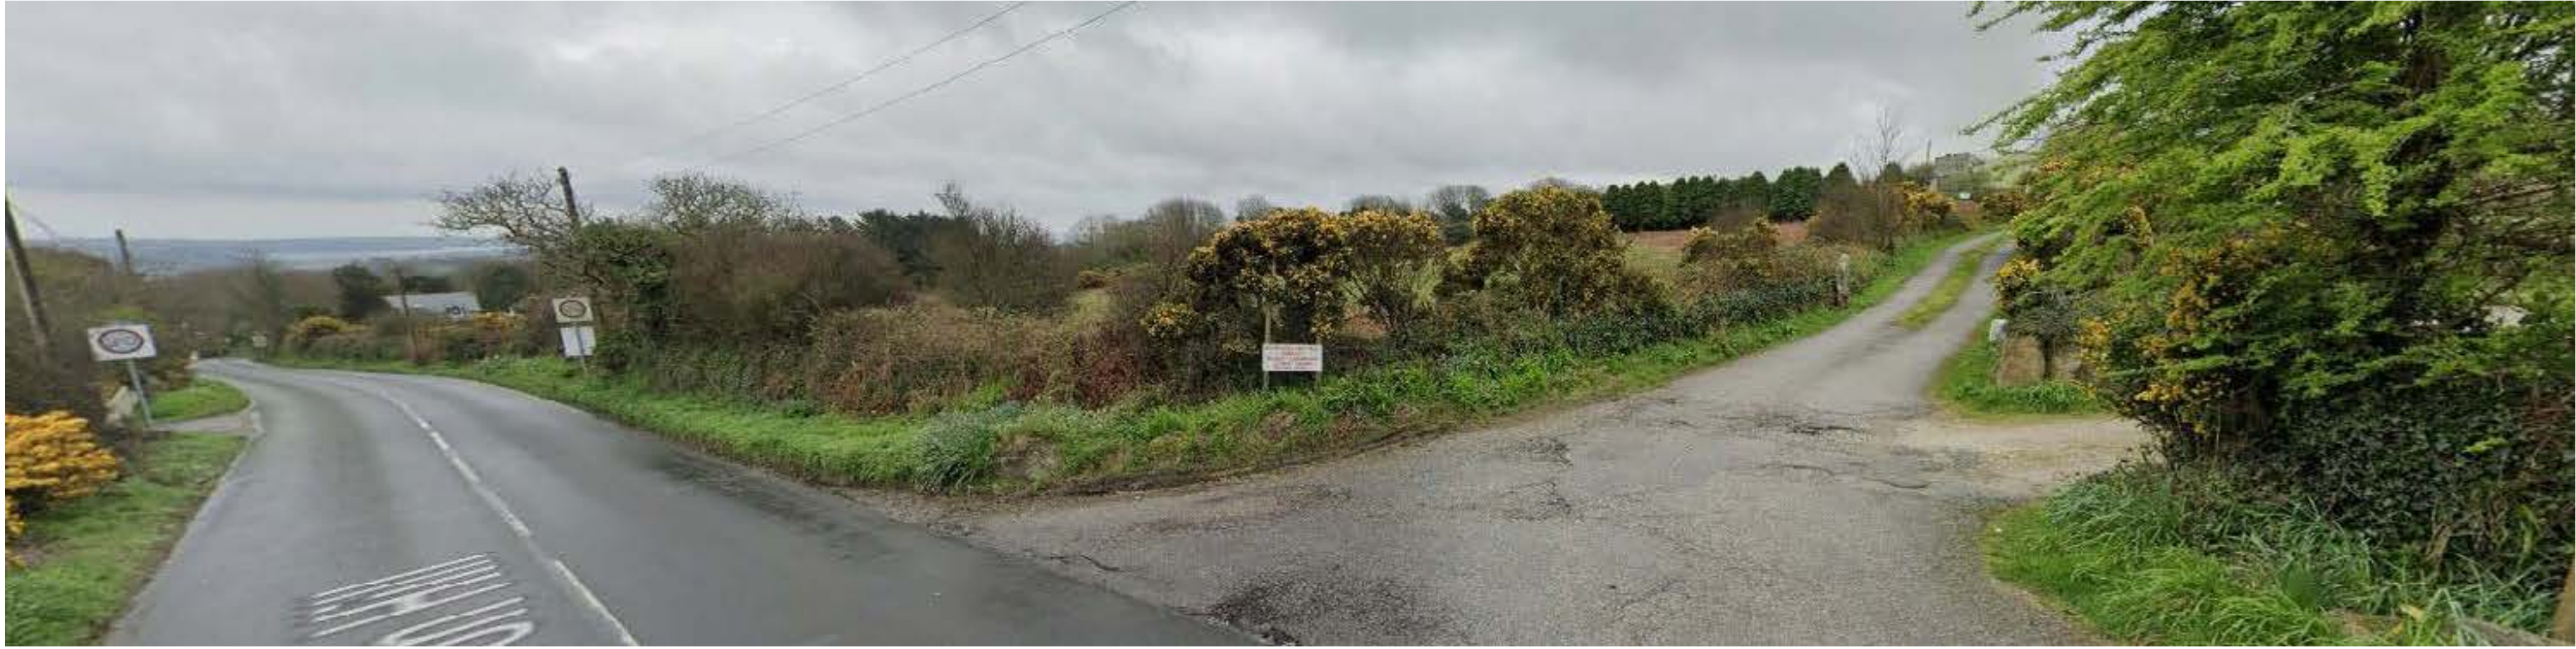
4) Quarry Lane & Antron Hill Junction;
 Speed restrictions, poor visibility to junction and overhead wires to review in design.

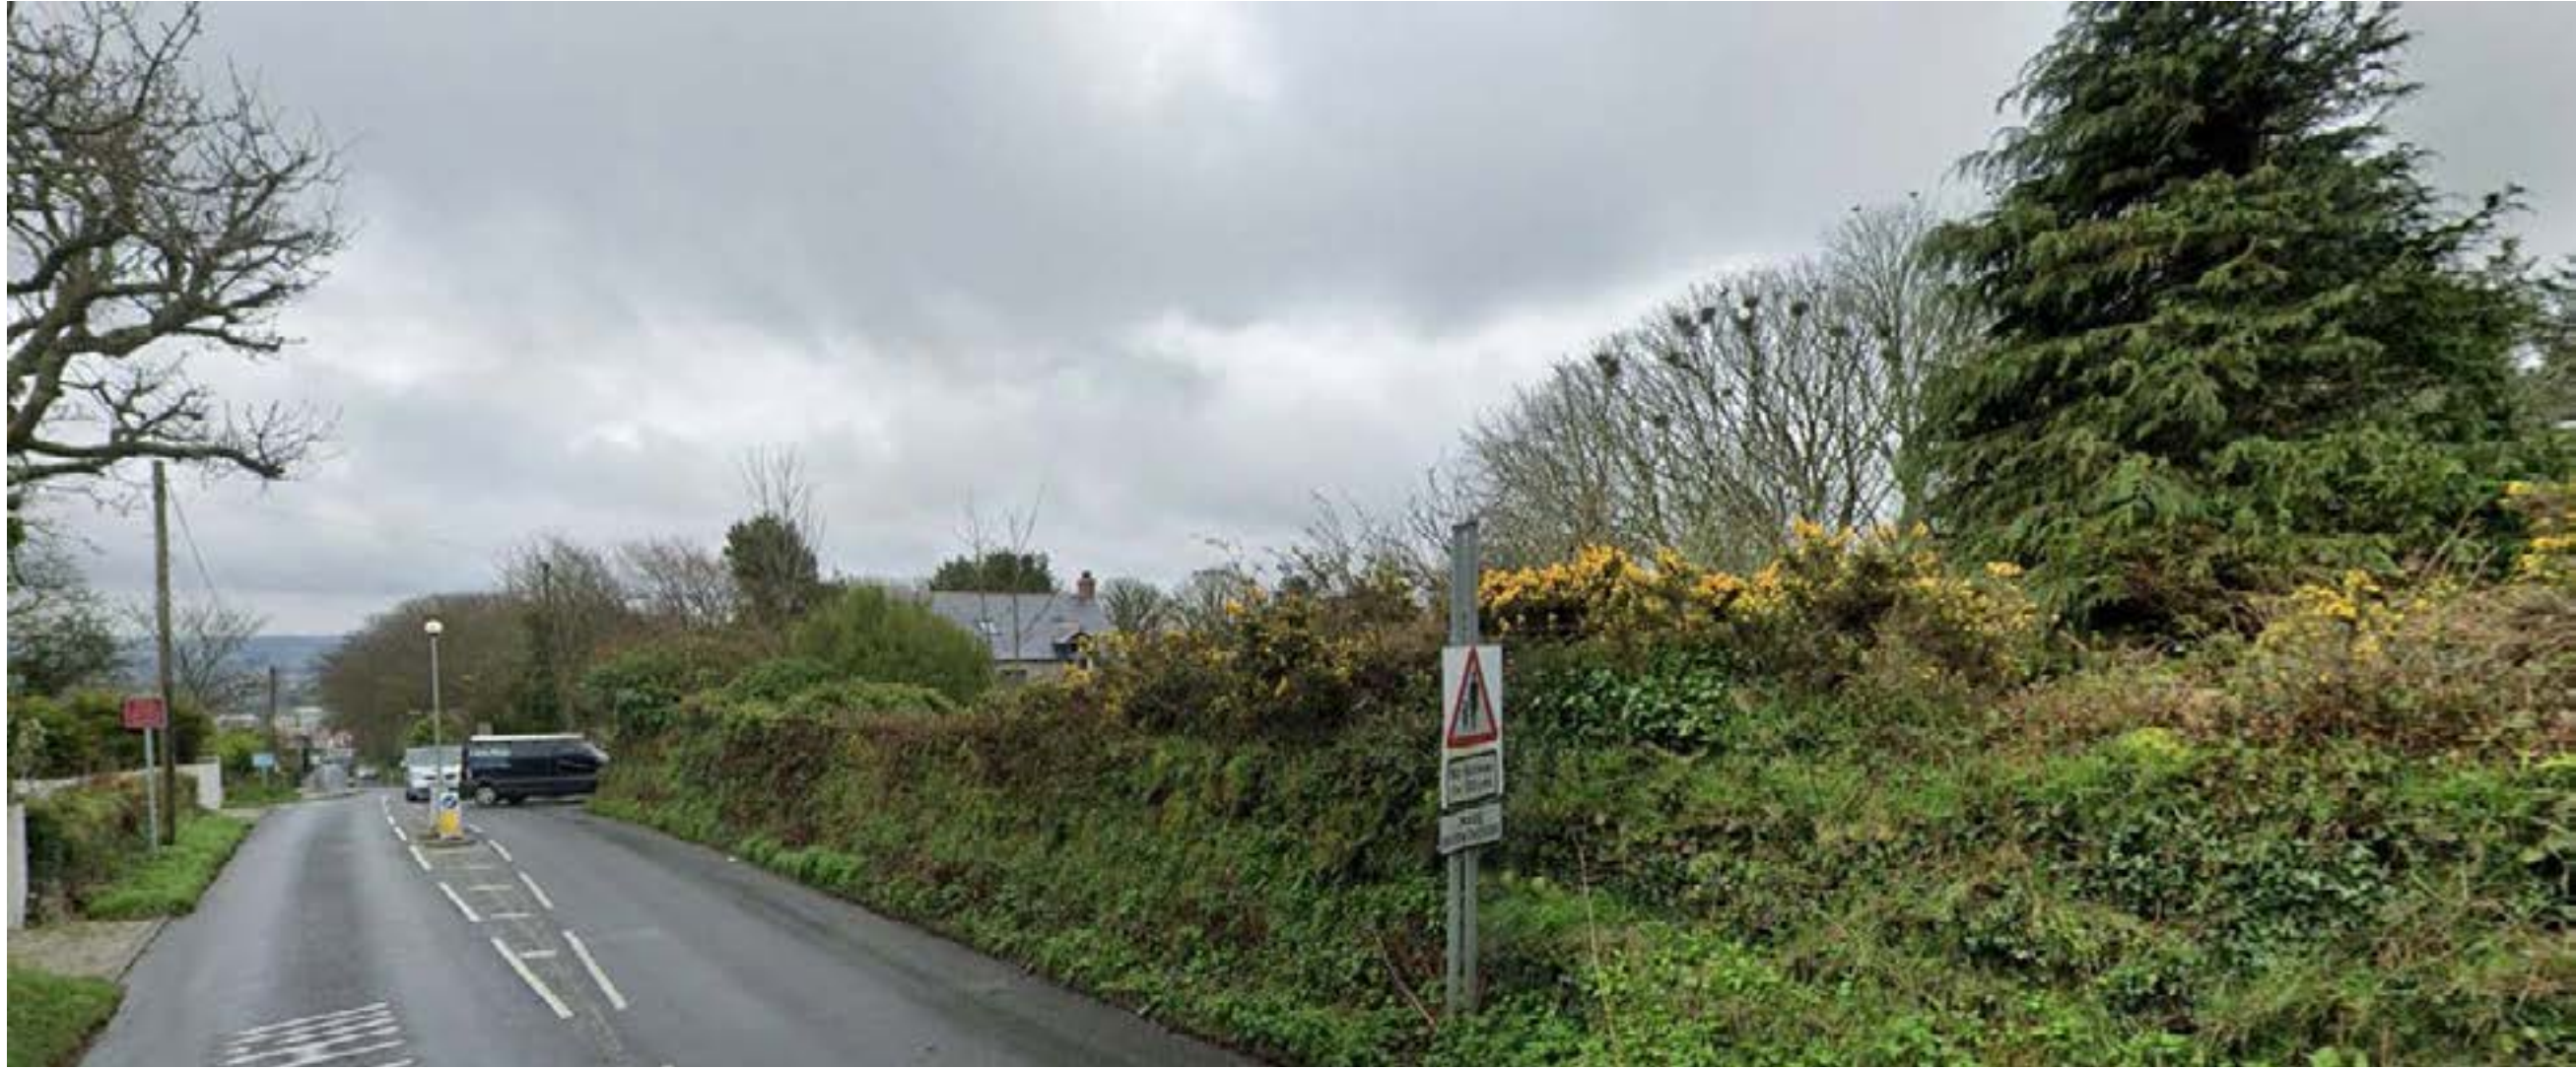
5) Antron Hill looking East;
 No footpath requires people to walk in road which is unsafe – safer connections to be reviewed as part of designs.

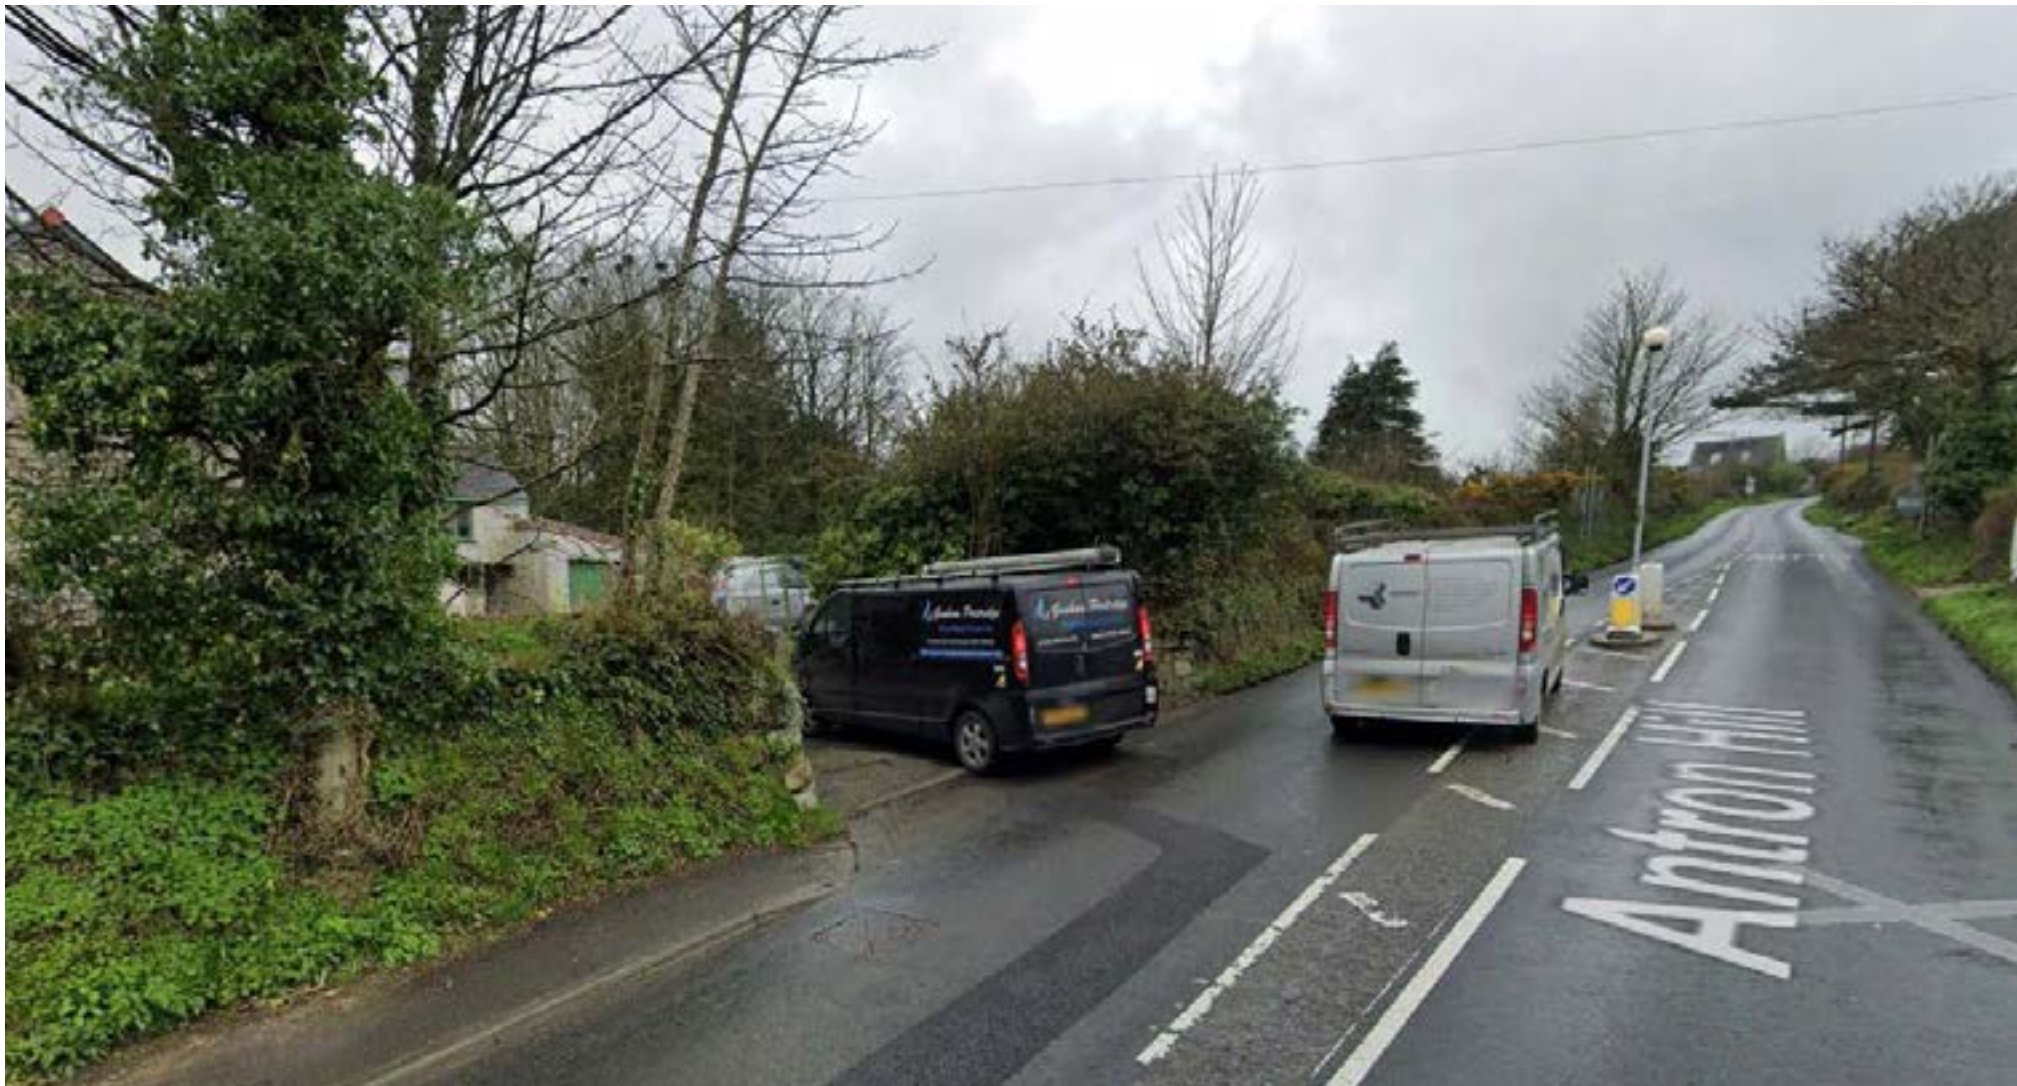
6) Antron Hill looking West;
 Existing footpath from Village stops – continuation or safe connection required
